ARES Performance Analysis Report

4/14/2024

The ARES (Autonomous Roving Exploration System) rover was one of two teams repeating AggieSat's 2022 - 2024 SCAMPS mission challenge. The mission remained the same: navigate toward a radio beacon transmitting at a specific frequency while avoiding obstacles, all on an undisclosed terrain meant to simulate extraterrestrial conditions. While the rover passed all subsystem tests and almost all integrated tests, lapses in final-stage full-system testing resulted in an incomplete mission. While the rover achieved motion in a straight line and collected data, it failed to demonstrate key elements of the mission, such as detecting the beacon and actively avoiding obstacles. The rover was also unable to collect a full five minutes of data. This report explains ARES' successes and failures, and details how future attempts at similar missions can be made more successful.

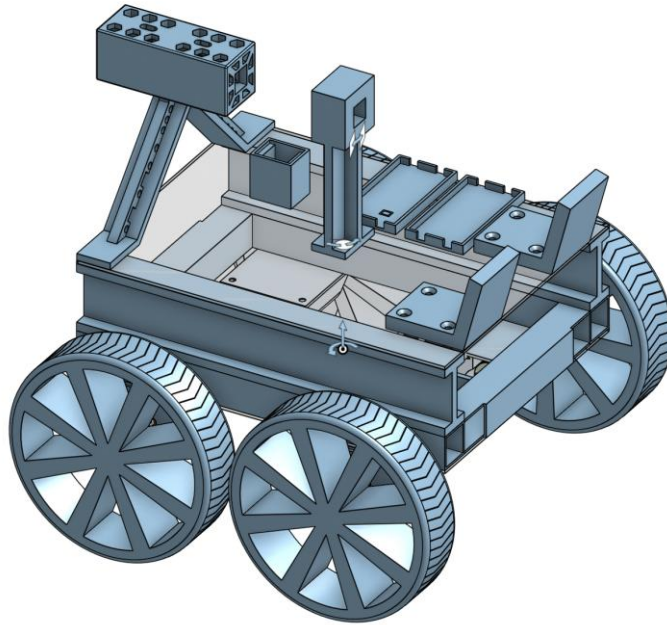
*Figure 4: Final CAD model of rover*

The end design was very close to the initial plan, except for the wheels. The wheels had initially been planned to be RC car wheels, but based on feedback from GNC, they were adjusted to be 3D-printed wheels to increase the height of the rover. There were some initial issues with mounting the 3D-printed wheels. The antenna mount was also completely redesigned after COM replaced the omnidirectional antenna with a directional antenna.

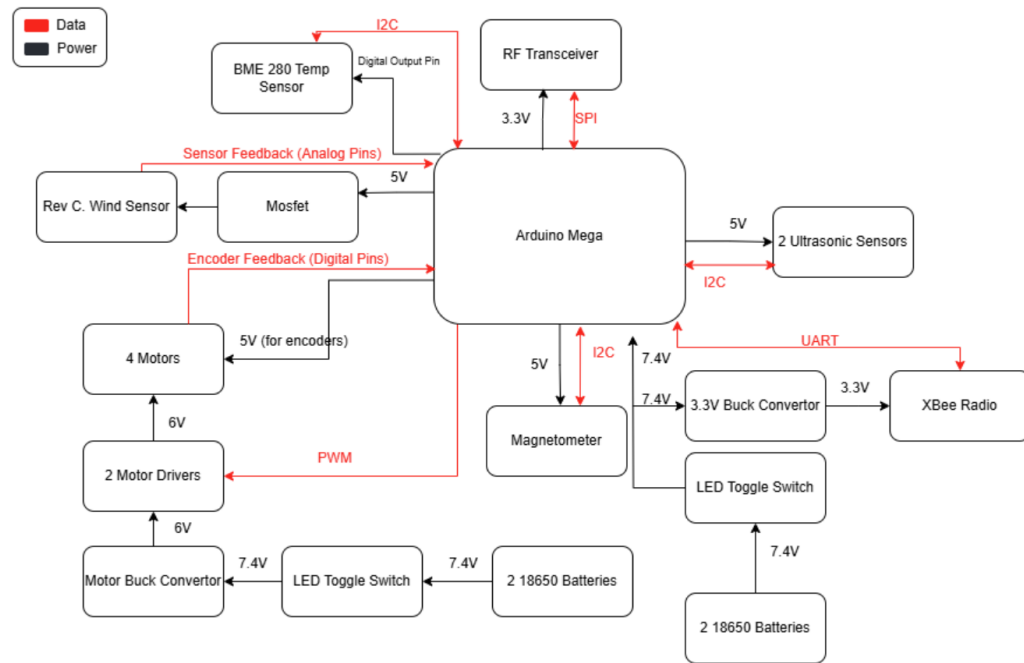
**Figure 5: Planned Wiring Diagram (Fall Semester)**

The original planned design (Figure 5) employed two separate 2-cell 18650 battery packs, each delivering 7.4V and powering distinct parts of the system through individual LED toggle switches. This setup added redundancy and allowed selective control of subsystems, but it also increased wiring complexity and introduced challenges in power distribution and balancing. In contrast, the final planned design (Figure Y) transitioned to a simplified and centralized power scheme by using a single set of four 18650 batteries in series, providing a total of voltage. This single source was then stepped down using dedicated buck converters to supply the needed voltage to various components, including motor drivers, sensors, and communication modules. Additionally, a 5V battery was introduced to power lower-voltage components separately, isolating sensitive sensors and encoders from high-power fluctuations.

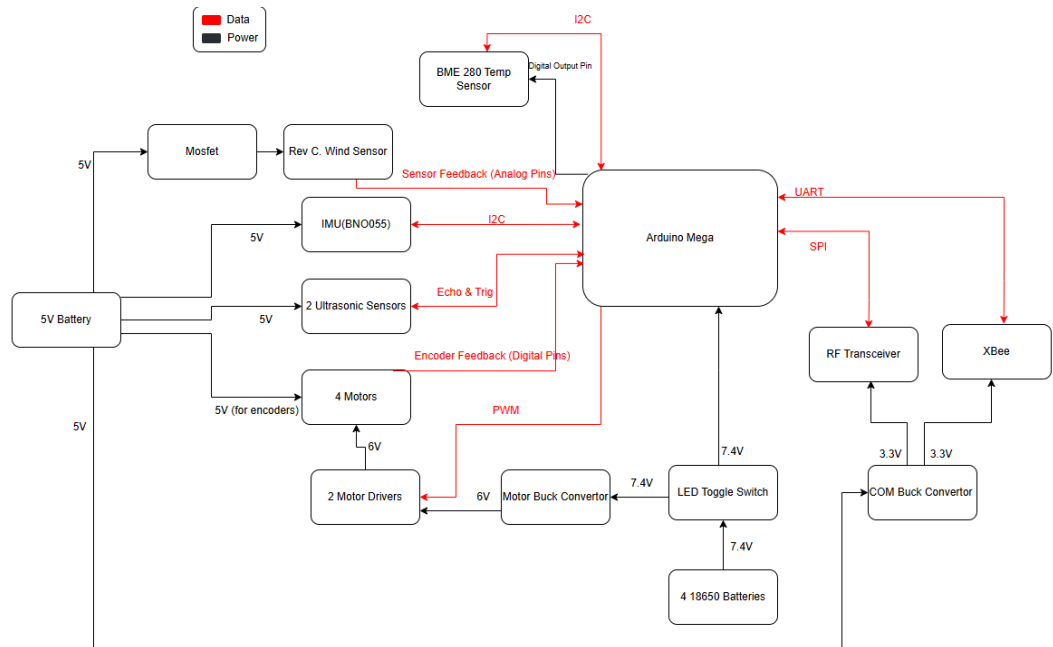
*Figure 6: Intended Wiring Diagram*

After each subteam finalized their respective component selections, the wiring diagram shown in Figure 6 was developed to serve as a comprehensive reference for the system's electrical layout. While this diagram does not fully represent the final implementation on the ARES rover, it provided the foundational framework upon which the intended wiring configuration was based.

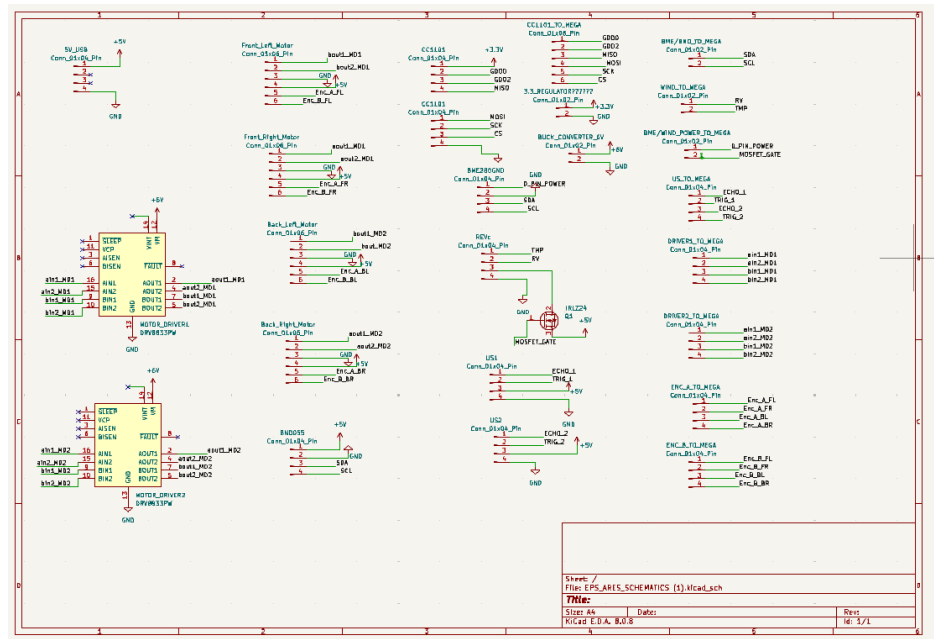
*Figure 7: PCB Schematic*

Last-minute modifications were required on the morning of the deployment due to connection issues with the 5V battery supplying power to the sensors. As a workaround, the sensors on the top level of the rover were disconnected from the PCB and rerouted using jumper wires and breadboards to interface directly with the Arduino. The components that were wired to the Arduino included the Rev C wind

The EPS subteam primarily struggled with the PCB. We had a weak connection from the USB breakout board to the PCB, which caused inconsistent power delivery to the PCB. This resulted in the team rewiring the rover away from the PCB directly to the Arduino Mega before the operation, which likely did not provide sufficient power to all of the components, especially the CC1101. The transceiver either did not receive enough power, or was fried since the component was rated for 3.3V but was connected to the 5V outlet. The justification for this was that the Arduino Mega simply did not detect the transceiver when plugged into the 3.3V outlet, but did so when connected to the 5V outlet.

The last-minute decision to design and order a PCB was also a cause of failure, since it also deviated the team from the standard component testing timeline. The reason for this decision was to organize the wiring for each component and reduce the odds of failure, but this adversely affected the system and led to a bottleneck. Ultimately, the PCB power failure proves that this decision was not thoroughly planned, and the system could have achieved key requirements without it.

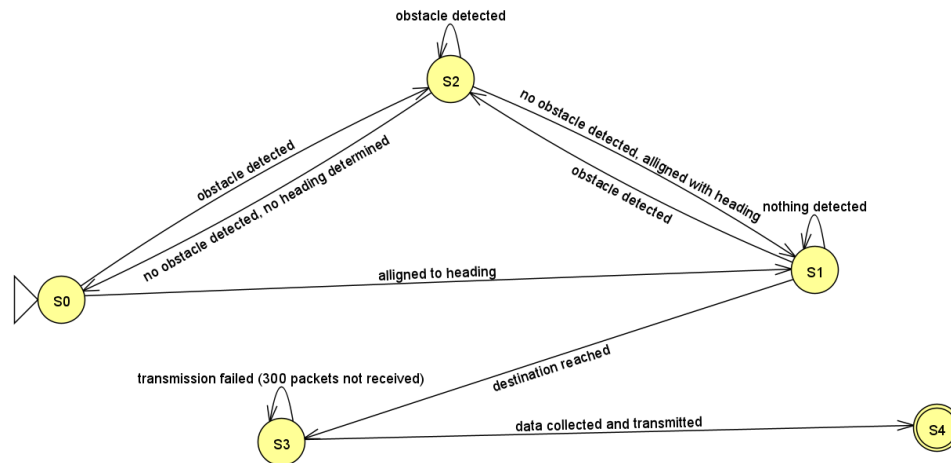
*Figure 8: Envisioned state machine diagram.*

The CDH team also planned for unexpected conditions and failsafes. For example, the team initially planned to have a traversal substate to handle situations where the rover was stuck in terrain. Although this code was developed, it could not be tested and implemented due to time constraints.

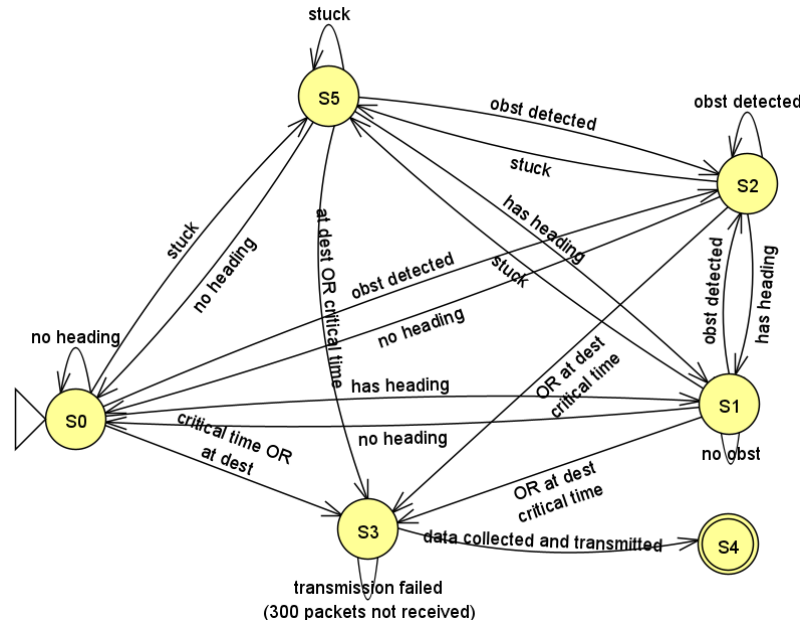
Figure 9: Final state machine diagram.

Another failsafe retroactively implemented was a condition to start data collection if less than ten minutes were remaining in the mission duration. This allowed the team to achieve minimal success by collecting and transmitting the required 300 datapoints if the rover was unable to get to the beacon location. These changes added to the complexity of the state machine, leading to its final form shown in *Figure 9*.

During the deployment, however, time constraints and uncertainty about the functionality of beacon finding and obstacle avoidance led to the state machine being heavily augmented for operations. Issues with mission-critical components discussed in later sections rendered the beacon finding (S0) and the obstacle avoidance (S2) states obsolete. Only the beacon-finding state was manually disabled; the obstacle-avoidance state was never invoked since the rover did not encounter any naturally occurring obstacles during operations. Due to unresolved issues and the delayed implementation of the stuck (S5) state, it was disabled before operations as well. As a result, the code running on the rover during operations was a heavily stripped and simplified version of what had been written and tested up to that point.
