Performance Analysis Report

GeoRGE

AggieSat Laboratory

4-28-2024

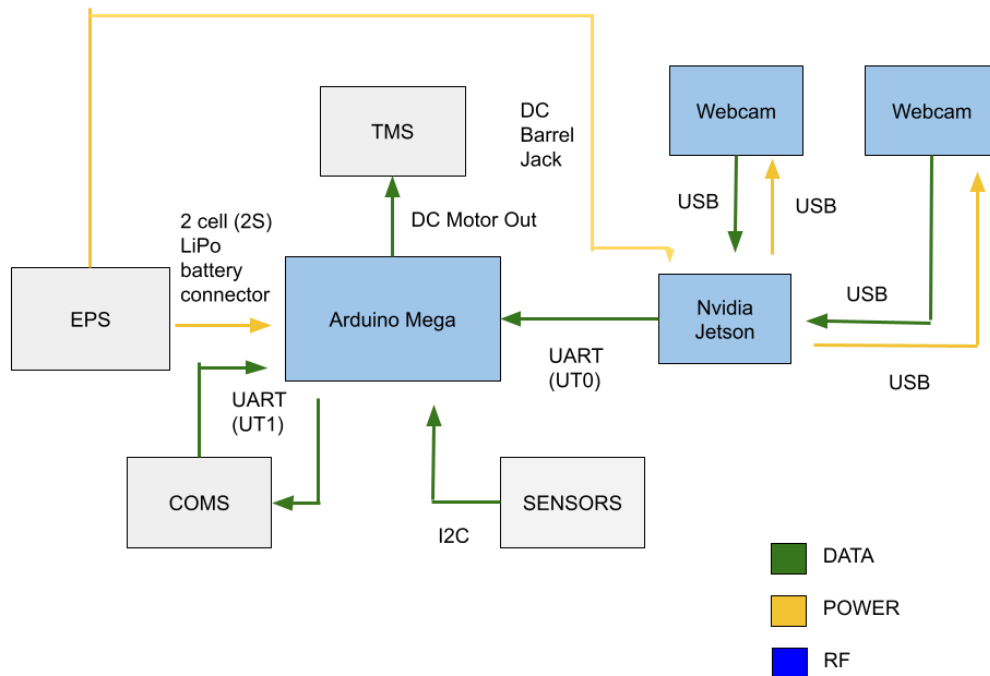
Figure 5. ICD for CDH Subsystem

The original ICD diagram for the BBB, seen in **Figure 5**, displayed how other components would connect to the beagle bone blue, but it was not thorough enough to detail how it would connect. The original IDC diagram didn't detail which pins, which connectors were needed, and it never went into detail about how the code would interact with whatever data was being connected between other subsystems.

Additionally, when switching from the BBB to the Arduino, the subteam never made another ICD diagram. Any connection information previously created wasn't centralized and was confusing to look at. This lead to two major problems on integration day:

- It took a long time to get all the motors to move because team members confused the pins that the motors were connected to and the wrong pins were in the code
- The NooELEC Radio module was unable to integrate with both the arduino and Jetson and we didn't know this until integration day. If a more thorough ICD diagram was written for the new system, this problem would have been caught earlier.

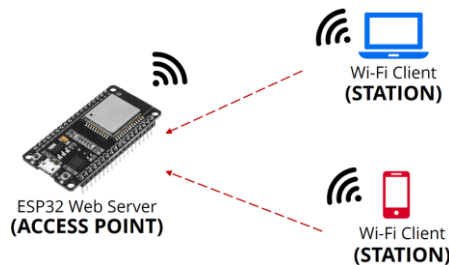
Figure 6. Diagram of Intended WiFi Communication Setup

Initial consideration of utilizing WiFi was heavily influenced by familiarity with Transmission Control Protocol (TCP) between two systems. WiFi is useful for wireless communication but failed to be useful in long distance communication. The module we used was the ESP32 Development Board and used a 2.4GHz WiFi chip for wireless communication. It was intended to work as seen in **Figure 6**.

Testing was conducted and it was determined that the maximum range of the WiFi subsystem was around 130 meters, which was significantly less than the

mission requirement of 354 meters. The ESP32 was easy to program using the ArduinoIDE but was not the correct choice for the COM ground station system.

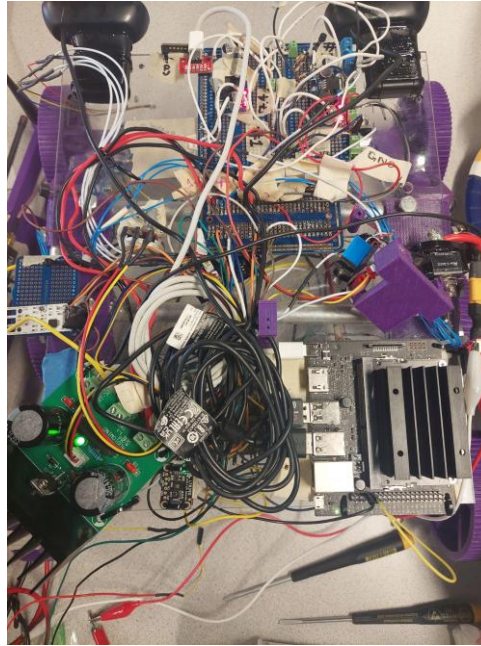
Figure 7. Example of Wire Organization Issues

The organization of the wires, or lack thereof, as seen in **Figure 7**, was part of the reason integration took as long as it did. Wires would get mixed up, causing troubleshooting to take longer as well. A few wires fell out or got lost and had to be replaced and re-soldered. Overall, wire organization could have helped a lot in resolving issues a lot quicker had it been done. A lot of issues came with integration, and the wiring only added to that.

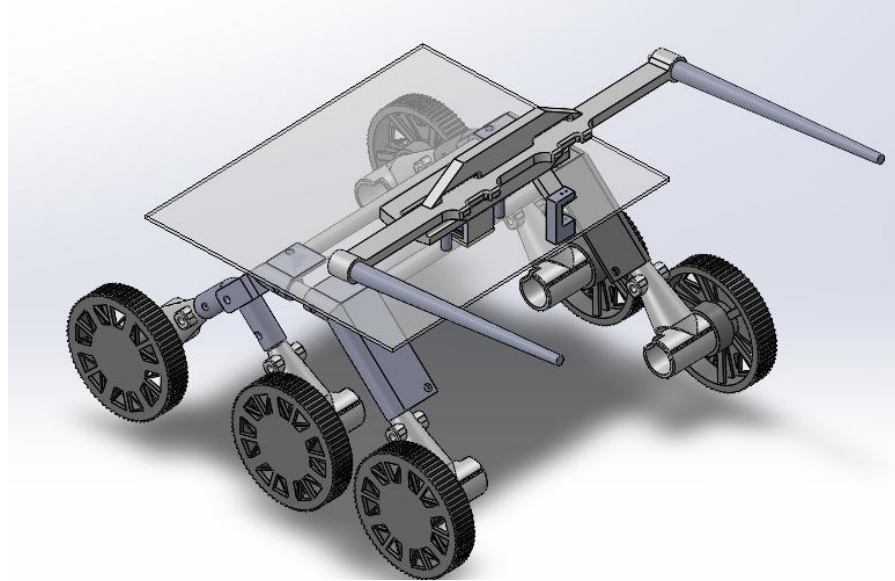
Figure 8. SolidWorks Model of TMS Subsystem

The rocker-bogie, seen in the SolidWorks model in **Figure 8**, was designed to act as both a chassis and suspension for a vehicle. Due to this, it is necessary for the vehicle to operate utilizing a six wheel drive system. The intention of utilizing so many motors allows for the rocker-bogie system to traverse and travel over

obstacles bigger than the wheel diameter. For this to happen, each set of wheels need to be able to drive a majority of the vehicle's weight independently.

Due to the issues outlined in 4.2.1, the team had to pivot from using six motors to four. The switch was done the week of the competition, leaving no time to redesign the drive system to accommodate only four wheel drive, additionally negating the purpose and requirements for a rocker-bogie. Instead of having six driving wheels, the front two and back two wheels were driving while the middle wheels were being driven.

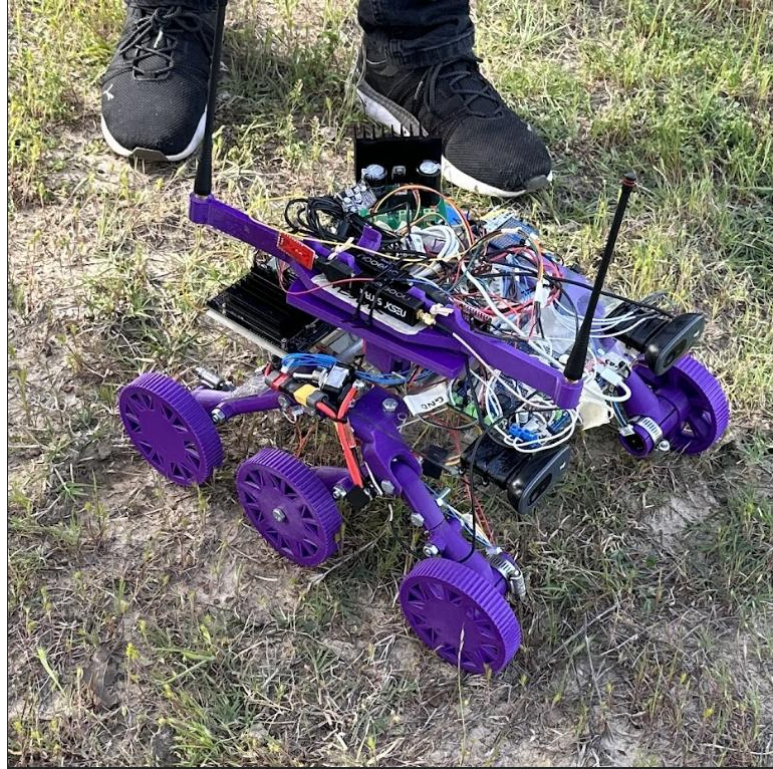
Figure 9. Completed Rover

The TMS subsystem team did not coordinate with the other subsystem teams about where their respective electronics needed to be mounted and housed until the last few weeks of the competition. This lack of coordination had the most impact on EPS. Because the teams did not take the time necessary to figure out the wiring required for their electronics to mount onto the chassis, EPS spent much more time soldering and desoldering to make all the components fit than necessary. Additionally, due to last second decisions about wiring and lack of updated documentation, the end product was visually a mess and difficult to work with and around, as displayed in **Figure 9**. Many wires were fully exposed to the elements and there was no wire management set in place. This set a high risk of wires being ripped from boards or getting caught on the ground during traversal. If decisions had been made earlier, TMS could have designed a method to conceal and protect the electronics better.
